BREMERTON GAS WORKS SUPERFUND SITE STATUS UPDATE

March 22, 2018

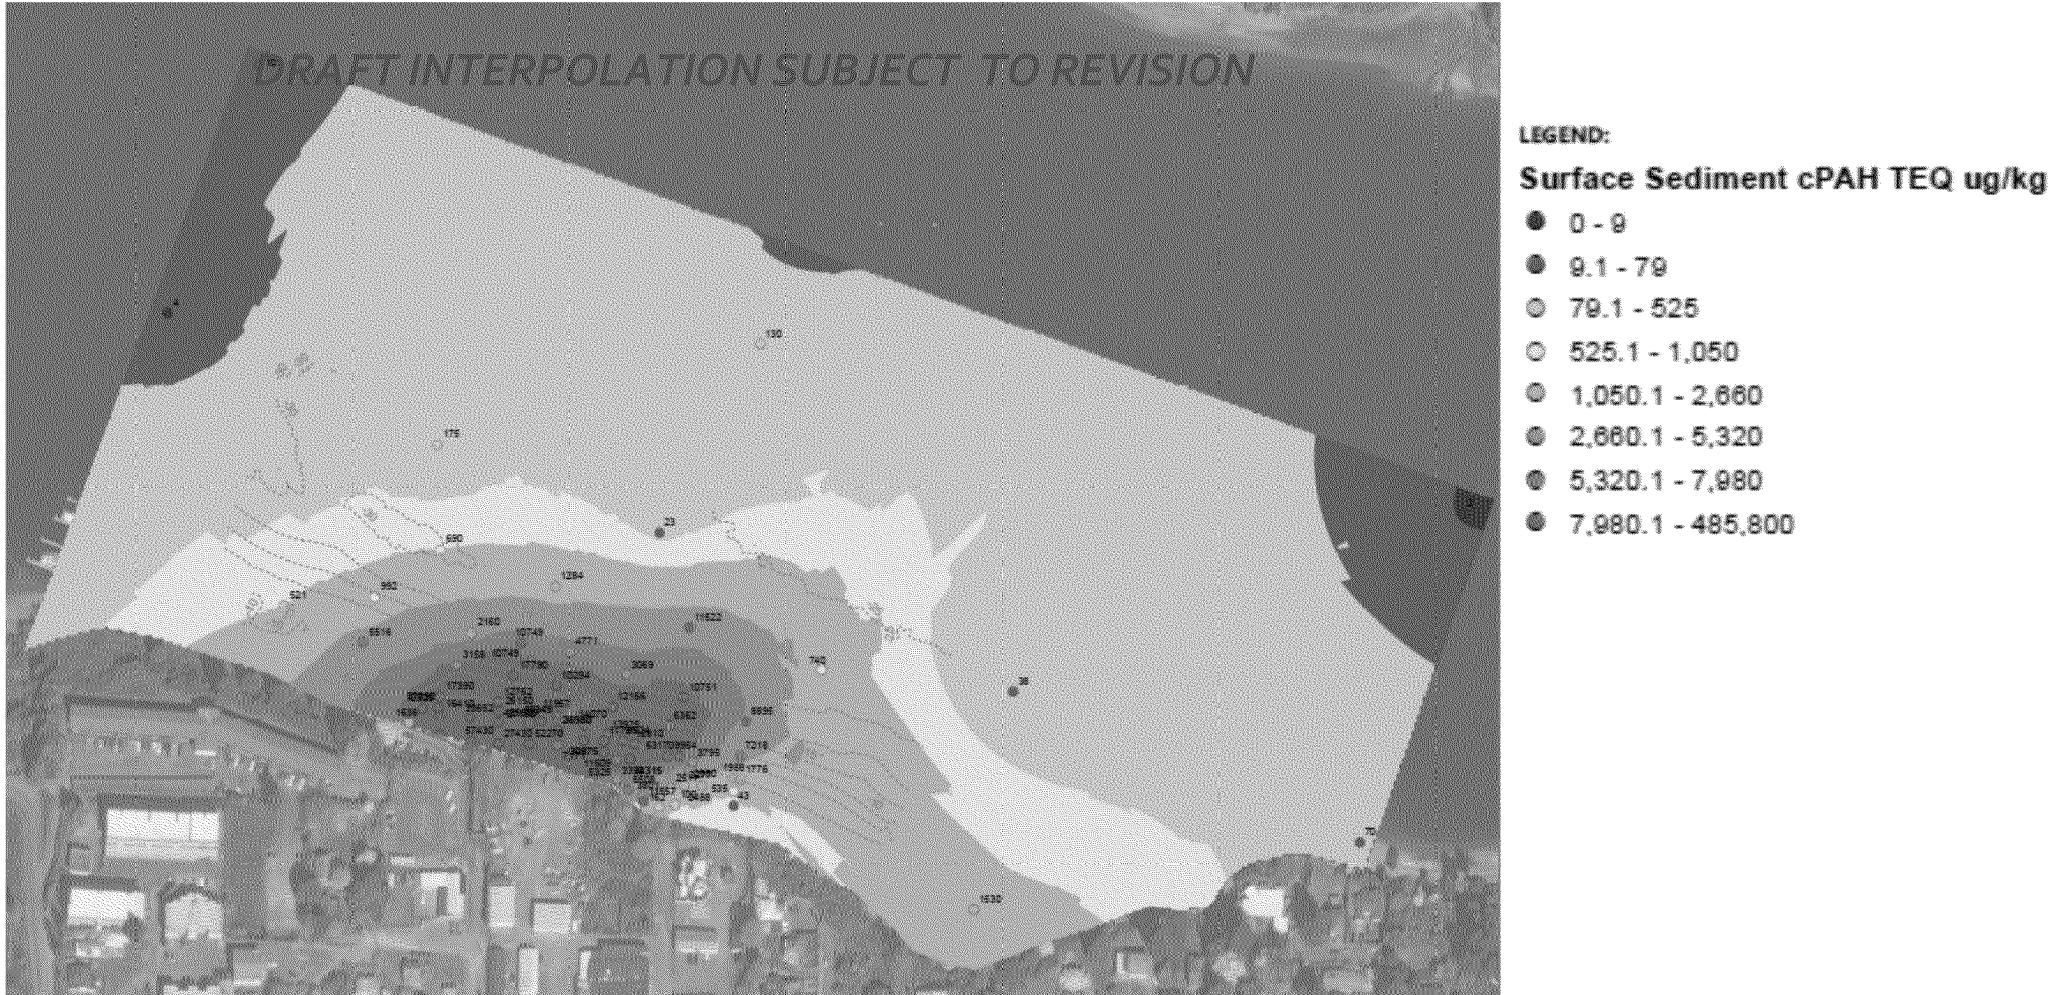
Surface Sediment PAH Results

- Initial evaluations suggest PAHs are the most significant chemical class within the ISA, as anticipated

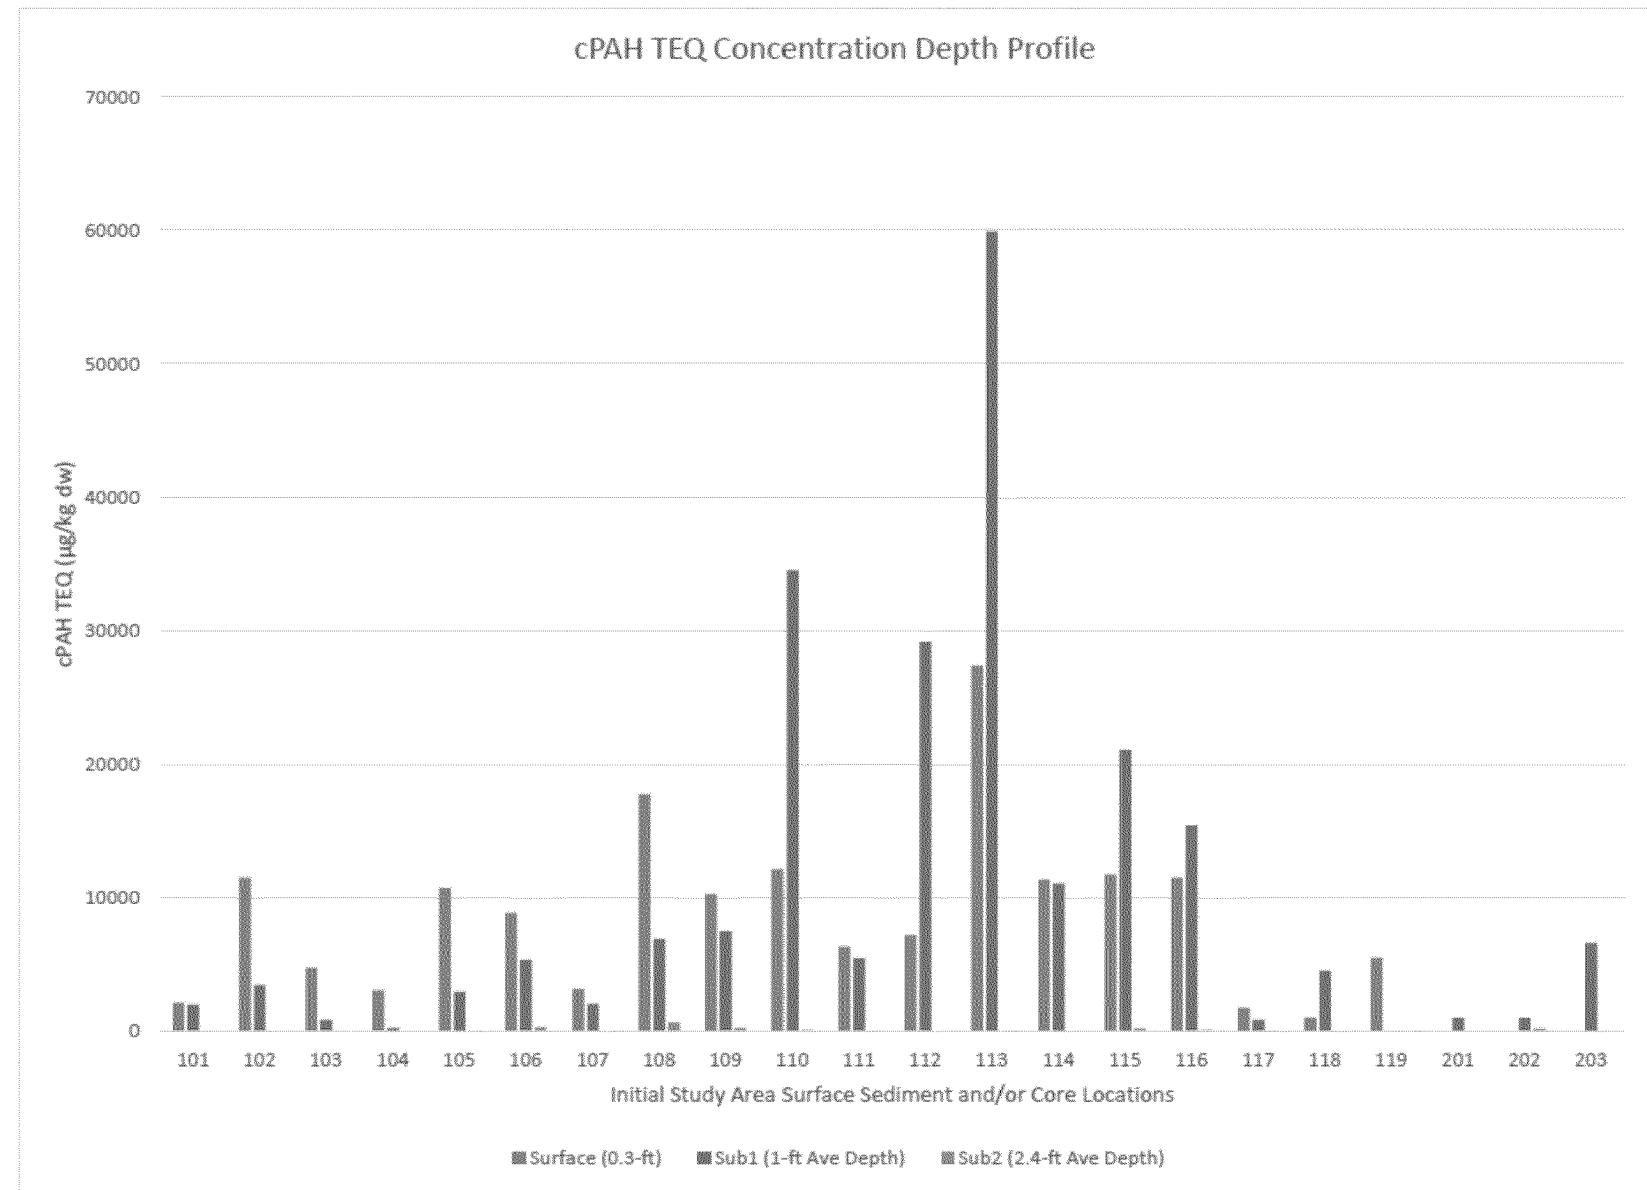
Subsurface Sediment PAH Results

- Subsurface cPAH concentrations reduce rapidly with depth
- More than half of deepest core interval below natural background levels
